CRREL-SR-76-8

A SURVEY OF ROAD CONSTRUCTION AND MAINTENANCE PROBLEMS IN CENTRAL ALASKA

E.F. Clark and O.W. Simoni

October 1976

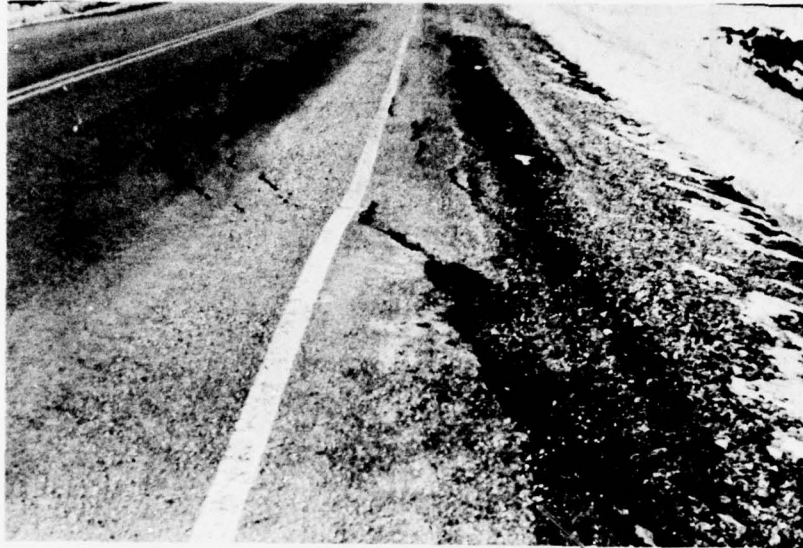
Figure 17. Embankment failure at road shoulder.

Figure 17, taken on the Elliott Highway, shows an embankment failure of a deep fill (approximately 15 ft) over a saddle. Severe road shoulder settlements and pavement cracking occurred on both sides of the road. Figure 18 shows a section of the Elliott Highway with a longitudinal crack that follows the center line. Tension cracks of this nature are

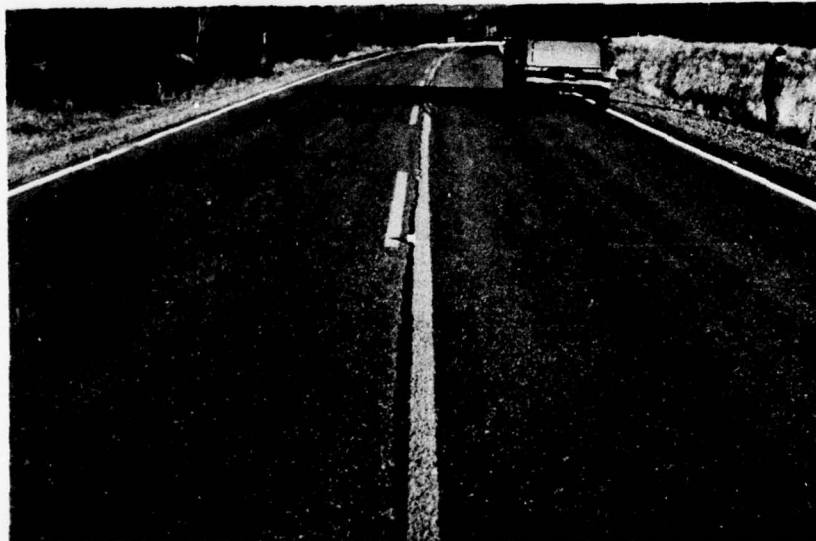
Figure 18. Longitudinal crack along center line.

prevalent in many places along Alaskan highways (as well as in more temperate regions). They permit intrusion of surface water into the embankment and result in subsequent failure. Some highway engineers have attributed these cracks to planes of weakness, resulting from paving one lane at a time with poor bonding between the two lanes.

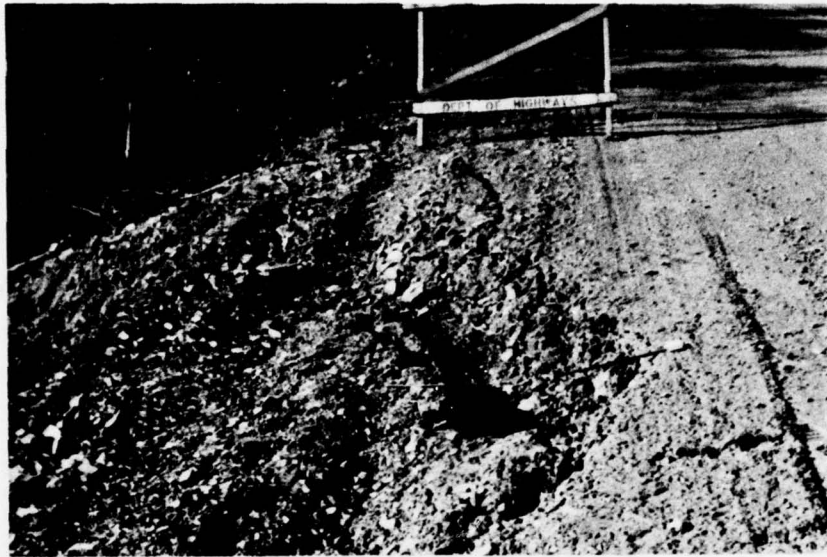
Figure 21. Slope failure along the Elliott Highway

Many instances of shoulder failure were observed during April and May of 1973. Figure 21 shows a typical slope failure along the Elliott Highway. In this case, high water and washout of the toe of the embankment caused cracking and subsequent sliding of the shoulder. Figures 22 and 23 show shoulder failure along the Trans-Alaska Pipeline Service (TAPS) road, and Figure 24 shows a similar failure on the Chena Hot Springs Road.

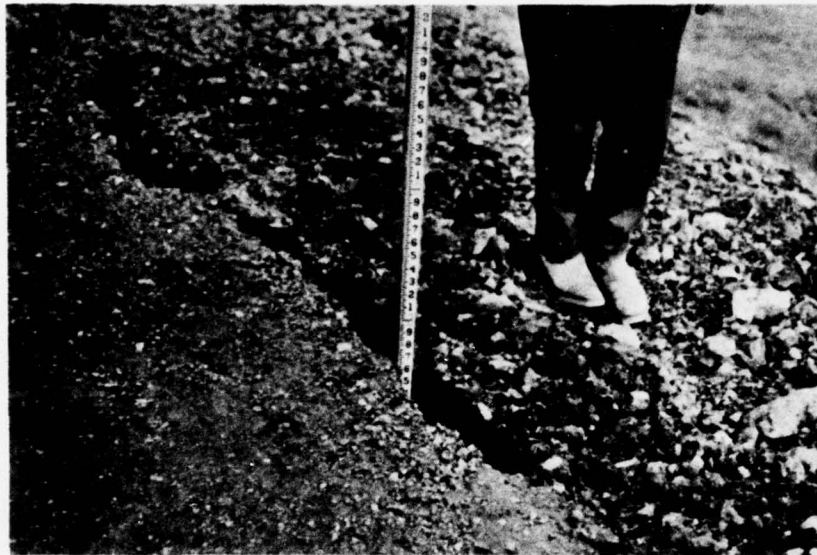
Figure 23. Longitudinal crack caused by settlement of embankment toe (TAPS road, mile 54.9).

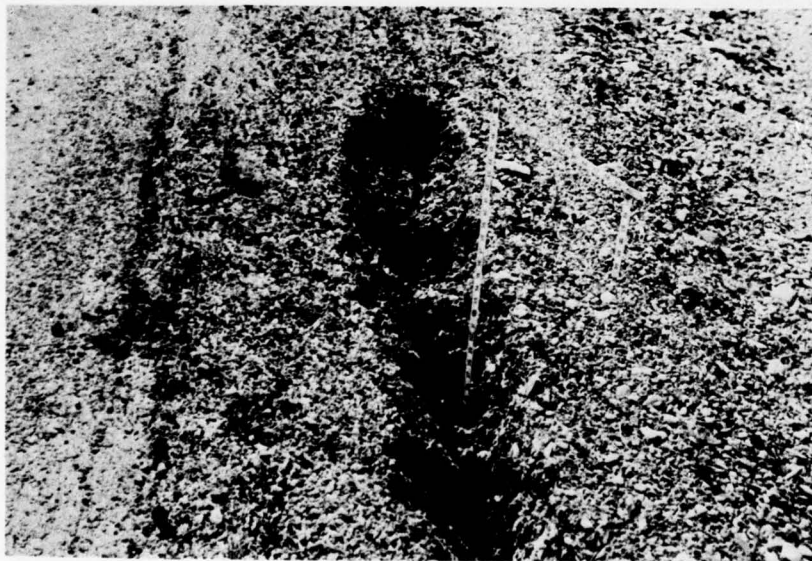
Figure 24. Shoulder failure caused by permafrost degradation under embankment toe (Chena Hot Springs Road, mile 12).

The above photographs illustrate but a few of many such failures observed. In cases in which failures are caused by permafrost degradation at or under the toe of the embankment, use of insulation such as polyurethane or polystyrene in and extending out from the shoulder might provide a solution (Fig. 25). Earth berms extending several yards from the embankment might also serve a useful purpose in preventing this type of failure.

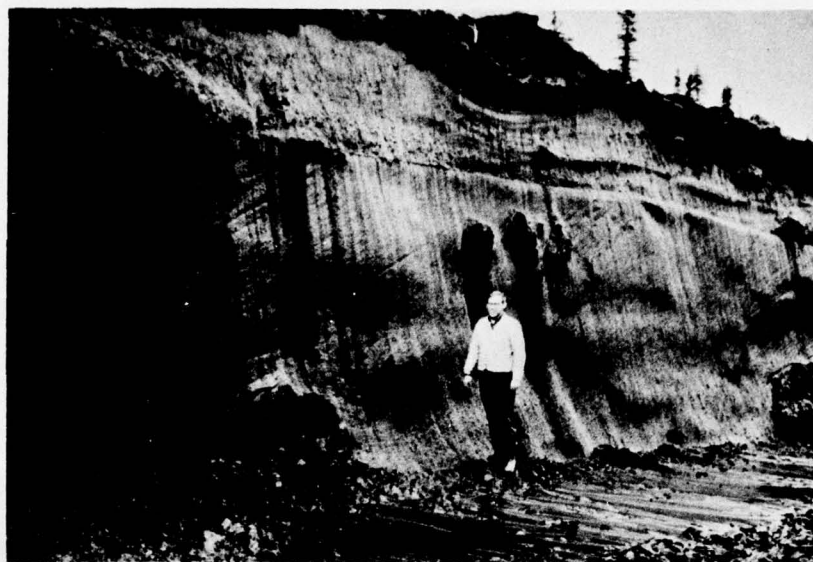
In a few instances sidehill cuts must be made through virtually pure ice, such as shown in Figure 27, which was taken along the TAPS road shortly after construction. In this case a vertical cut was made. Figure 28 shows another sidehill cut on the TAPS roads. Subsequent observations revealed that in less than two years the ice had receded about 4 ft, the grasses and other vegetation had sloughed down over the ice, and the cut had stabilized, as shown in Figure 29 which was taken in the same general location approximately two years after construction.

Figure 27. Vertical sidehill cut through ice at milepost 23.9 on TAPS road (from Smith and Berg 1973).

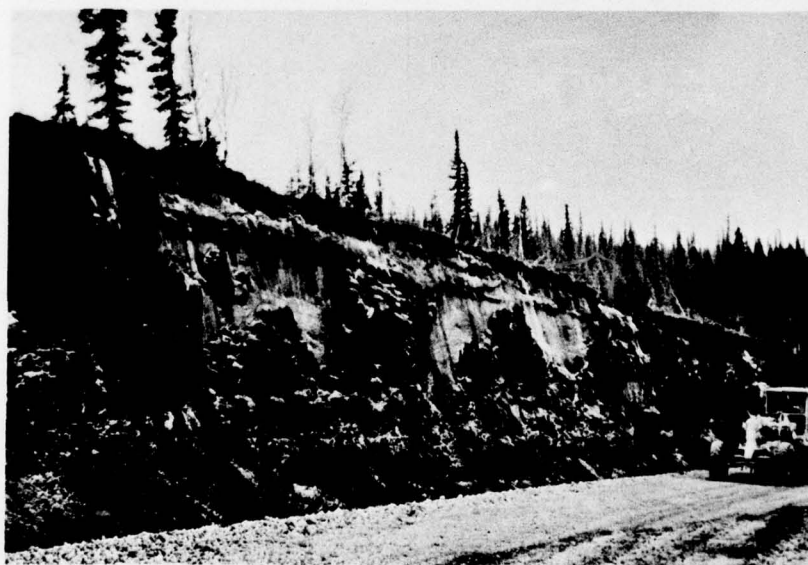
Figure 28. Vertical sidehill cut on TAPS road, 23 April 1970 (Smith and Berg 1973).

Figure 29. Same general location as shown in Figure 28 after approximately two years (photo. by N. Smith).

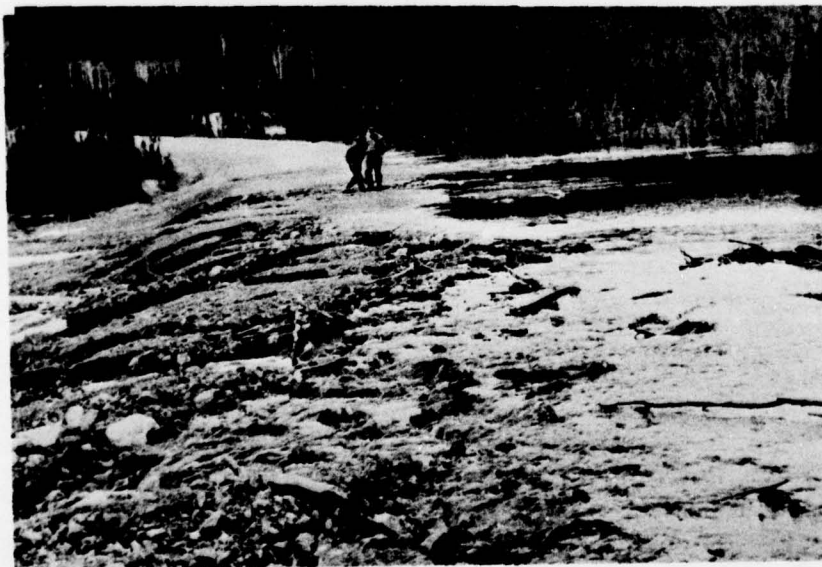
Hydrologic data are limited in many parts of Alaska. Each spring, during the high water period, some roads may sustain serious damage from roadside flooding. At the height of the spring melt, surface runoff is often extreme because the subsoil (including free draining ground) is still frozen. Figure 33 shows an excellent example of a roadway (TAPS mile 5.6) washout resulting from culverts unable to carry the accumulating volume of water. Ice was not involved in this situation, as both small culverts were carrying full flows of water.

Figure 33. Washout along TAPS road (mile 5.6).

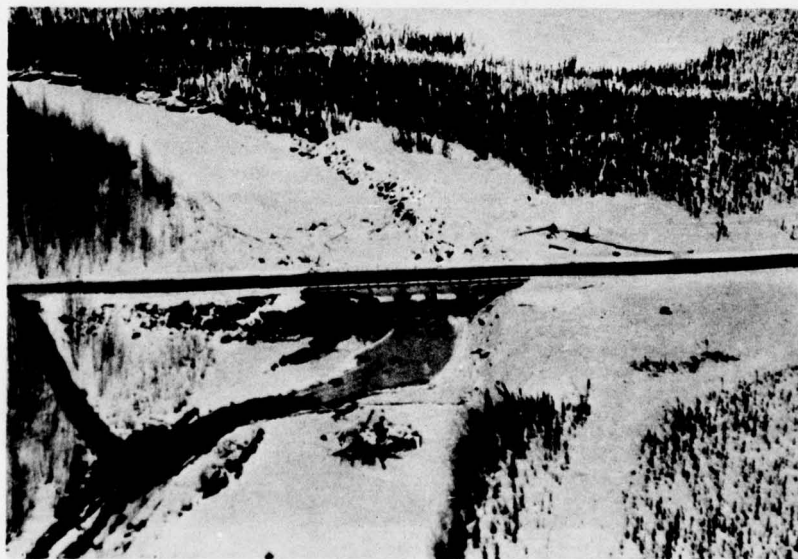
Figure 35. Hess Creek Bridge on TAPS road.

Figure 35 shows the Hess Creek bridge on the TAPS road. This is a pile bent bridge, constructed with "H" piles. The bents are probably

too close together, thus causing debris and ice buildup. Figures 36 and 37 show serious damage that this bridge sustained from log jams and repeated impacts from ice floes. Although unsuccessful at this location,

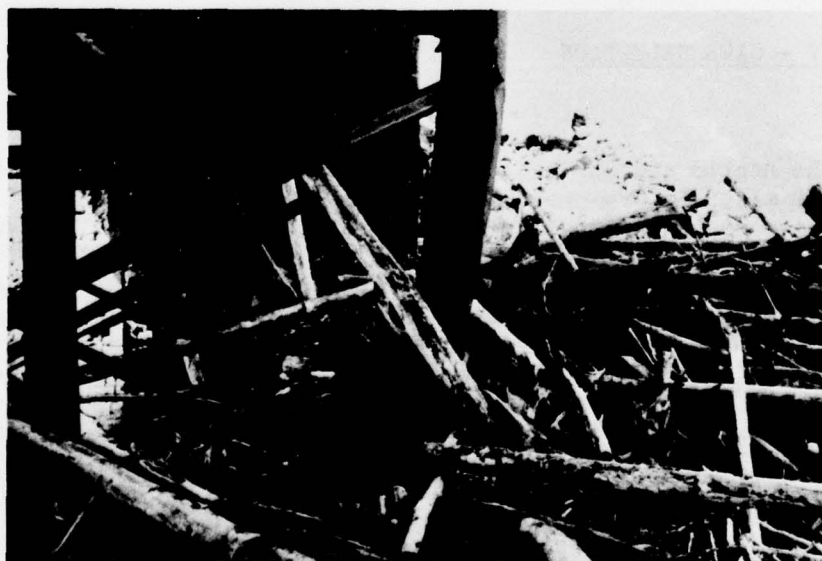
Figure 36. Damage to Hess Creek bridge from ice and debris during high water and ice breakup.

Figure 37. Closeup of damage to Hess Creek bridge.

deflection devices such as those used for a pile bent bridge across the Chena River on Fort Wainwright (Fig. 38) have been found useful for some bridges. These deflectors are constructed of "H" beams and placed approximately 15 ft upstream from the bents. A crane is used to clear debris from the deflectors.
